MONITORING SOIL EROSION AND LAND-USE CHANGE IN NATAL USING
REMOTE SENSING WITH SPECIAL REFERENCE TO THE MFOLOZI CATCHMENT

by ULRICH LOOSER

DEPARTMENT OF WATER AFFAIRS
HYDROLOGICAL RESEARCH INSTITUTE

COLLOQUIUM PAPERS

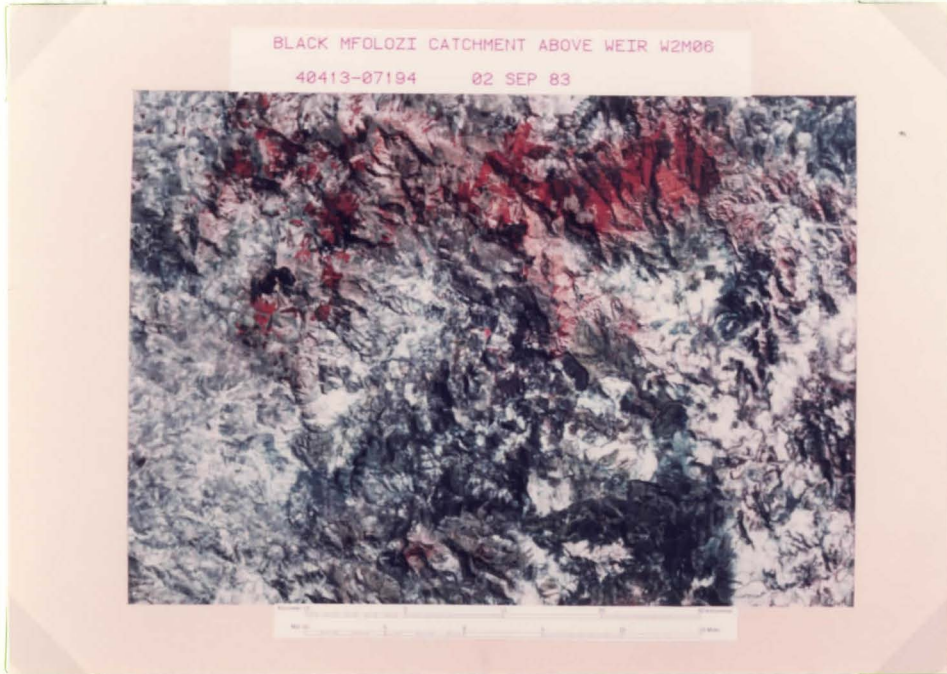
It can be clearly seen that river channel widening occurred from the watershed to the Mfolozi flood plain. The gradients of the rivers in this area are steep, therefore floods which had a very high erosive power necessary for streambank erosion and channel deepening had the potential to significantly alter channel geometry. As a result the river channels are all well defined on the post-flood image in comparison to the pre-flood image.

Sedimentation occurred in the river channel, especially on the inside of river bends and where the river flooded flat areas next to the channel. Thus sedimentation mainly took place during the latter stages of the flood. However, these sediment deposits are probably negligible compared to the amount of sediment which was exported from the catchment. There is no clear indication of sediment deposition on cultivated areas.

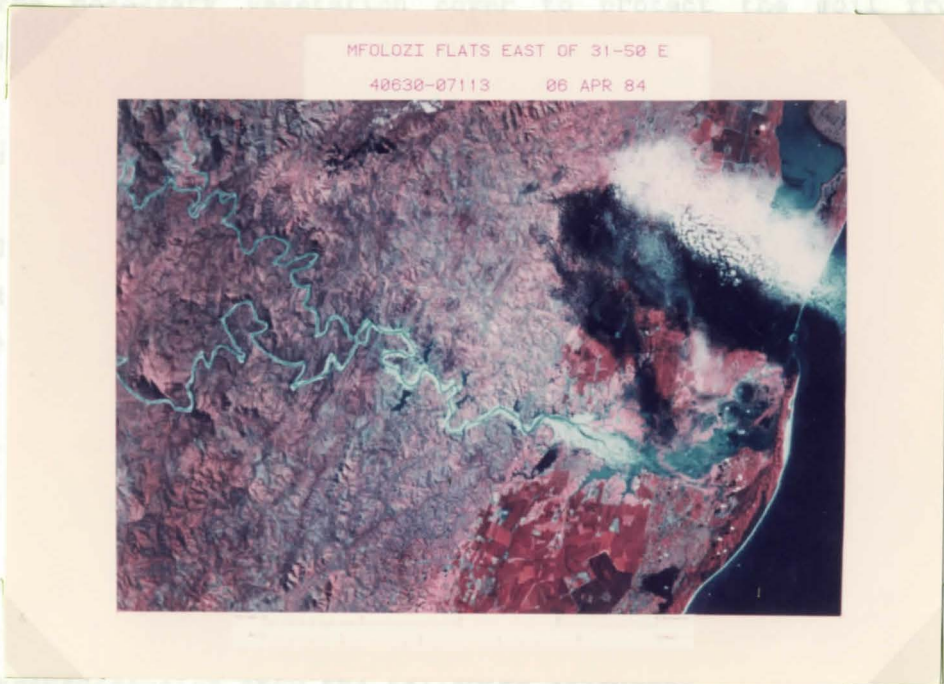
A significant change in riverine and irrigated vegetation took place. The riverine vegetation was washed away on the banks of the White and Black Mfolozi. Downstream of the confluence of these rivers the riverine vegetation was buried under sediment deposits. Approximately 60 km² of irrigated land on the Mfolozi flood plain was also buried under sediment deposits. About 7,5 km² of irrigated lands were still standing under water on the 6th April, two months after the flood. Approximately 38% of the total cultivated area in the Mfolozi floodplain was destroyed by the Domoina flood.

Apart from the destroyed flood plain and the areas in the vicinity of the main river channels the vegetation appears to have recovered fairly well. However, large areas which were overgrazed and damaged by erosion still do not have the necessary vegetation cover to protect the soil from further erosive events.

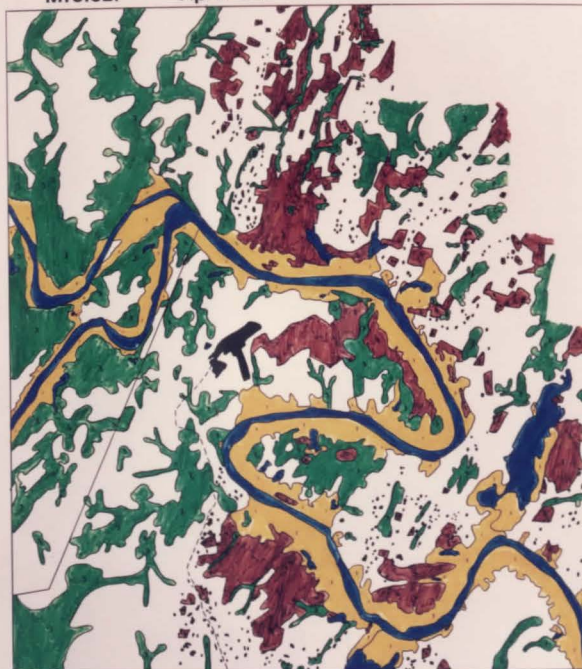
Mfolozi April 84

On both the 1960 and 1984 photos almost no erosion processes are evident, except along some tracks and along the river-bed of the Mfolozi. The most eye-catching characteristics are the 851 ha of sediment deposits along the Mfolozi on the 1984 photos compared to the 50 ha in 1960. The Domoina flood buried a large amount of cultivated land along the Mfolozi under medium to thick sediment deposits. These deposits often cut off and dammed up the water courses of the small tributaries. It seems that more sediment was deposited in the sample area than

0 1 2km Forest & Shrub Sedimentation Kraal, Building
Agricultural Area Water Road

exported. The erosive power of the Domoina flood altered the course of the Mfolozi at two places. Cultivated land was washed away, but no houses were endangered by that process.

During the last 24 years the cultivated area increased from 433 ha to 783 ha. The 1984 figure does not consider the approximately 300 ha of cultivated land in the sample area which was seriously affected or totally destroyed by the Domoina flood. The 1984 photos show that the cultivated areas not affected by the flood are in a generally good condition with almost no signs of erosion processes.
