Technical Report: Ecological Status for Rivers of the Overberg Region 2004/2005

E.L.Herdien¹, C. Petersen², C.Reed³, D.Impson¹, A.Belcher⁴,
T.Ndiitwani⁴, S.Buthelezi⁵ and A.Matoti⁶

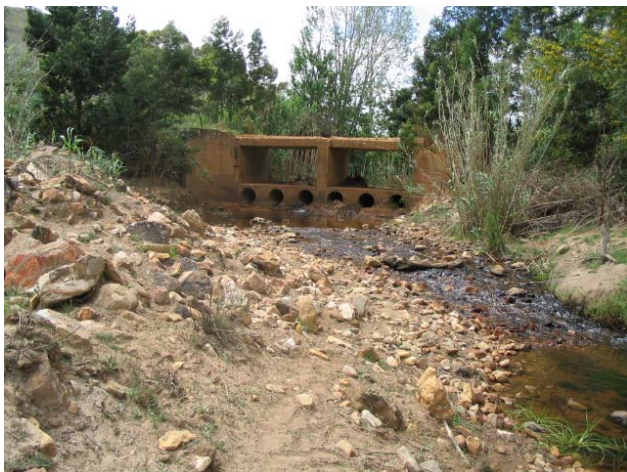
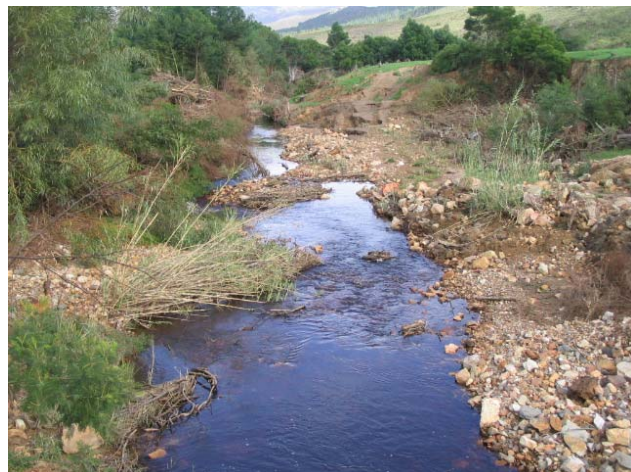
Plate 3. Site B2 – October 2004
(looking upstream)

Site B2 was located on the farm Kanaan in the lower foothill zone. The channel is alluvial and the dominant bed material is sand, although cobble also occurs resulting in a pool-riffle reach type. Both banks showed a moderate to low stability with sparse vegetation cover and removal of alien vegetation downstream of the bridge. Alien trees dominated the left hand bank (LHB) at the site and bank scour occurred. Upstream of the causeway the channel was very narrow (2-4m) due to dense alien vegetation on both banks and in stream as well as dense reed growth within the channel. The RHB was filled in with mostly building rubble and sand to protect the adjacent grazing land resulting in localized channel straightening. After a flood event in April 2005 a steep channel was scoured on the LHB and the instream

vegetation was removed. Causeways occur within the reach and both banks were unstable for approximately 20m downstream of the bridge. Extensive sediment is supplied to the channel and the habitat diversity and cover was moderate.

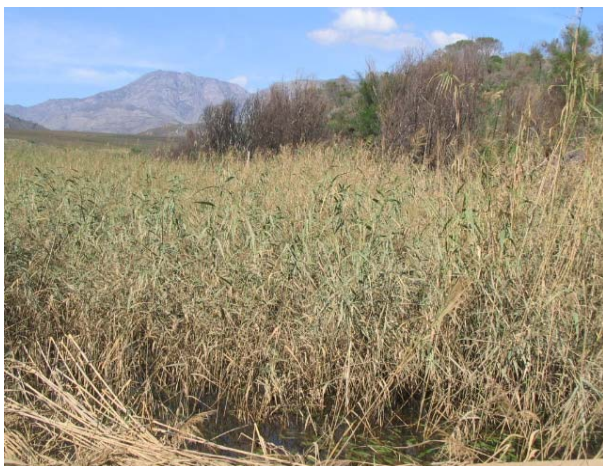
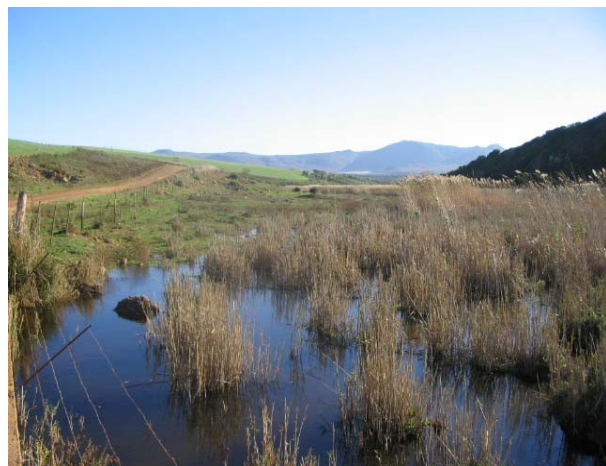
Plate 7. Site SW1- October 2004 (looking upstream)

Site SW1 was located at a causeway in the lowland river zone and agriculture and livestock farming dominated the surrounding landuse. The channel type was alluvial and dominated by a sand substrate. The reach was classified as a flat bed and mid channel bars occurred within the channel. Extensive reeds grew within the riparian zone and it also dominated within the channel downstream of the causeway during low flows. Both banks were moderately stable and showed signs of trampling by livestock and fluvial erosion due to recent flooding, which had occurred at the time of sampling. Alien vegetation had a moderate impact and the local sediment sources supplied to the channel was extensive. Habitat diversity and cover were limited. **Impact class: C.**

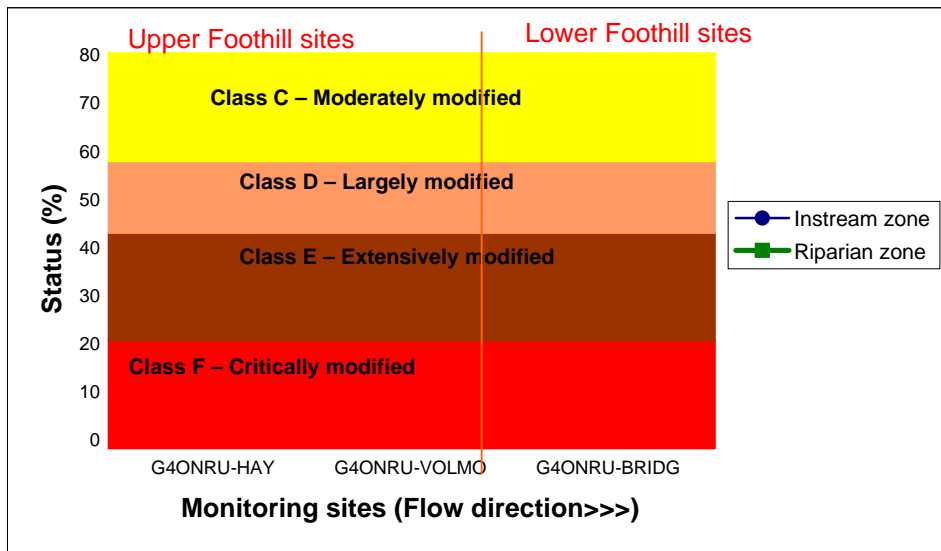
Figure 9. Summary of Index of Habitat Integrity results for the Onrus River System

The Onrus Rivers' instream zone habitat integrity is less modified than that of the riparian zone (Figure 9). The instream habitat integrity deteriorates from being moderately modified at the uppermost site to being extensively modified at the second site as the effects of agriculture and urban developments become evident. Subsequently the instream habitat recovers slightly to largely modified at the lower site. The riparian habitat integrity rapidly deteriorates from extensively modified at the uppermost site to being critically modified at both the lower two sites.

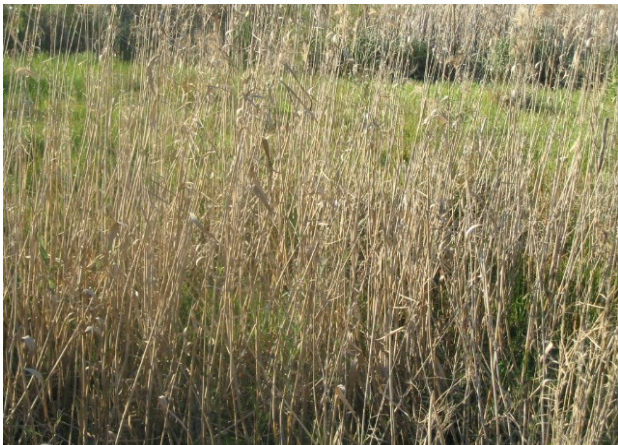
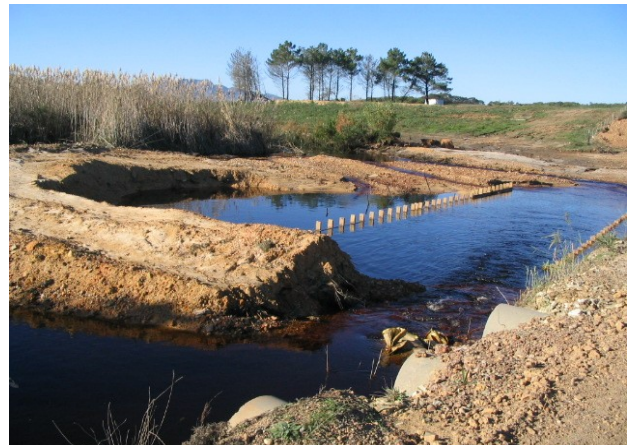
Plate 17. Site 3 Uilkraal River before construction – October 2004 (upstream)

Initially four sites were selected on the Uilkraal River but one was discarded from the assessment because of construction of a new causeway across the site Plate (17 and 18). The first site was located within the Salmonsdam Nature Reserve, site 2 at a causeway below farming and site 3 below the newly constructed Kraaibosch Dam (Figure 10). The general site information for each site is shown below Tables 32, 33, 34.
