EASTERN CAPE RIVER HEALTH PROGRAMME

TECHNICAL REPORT: MTHATHA RIVER MONITORING, 2004 - 2006

August 2006

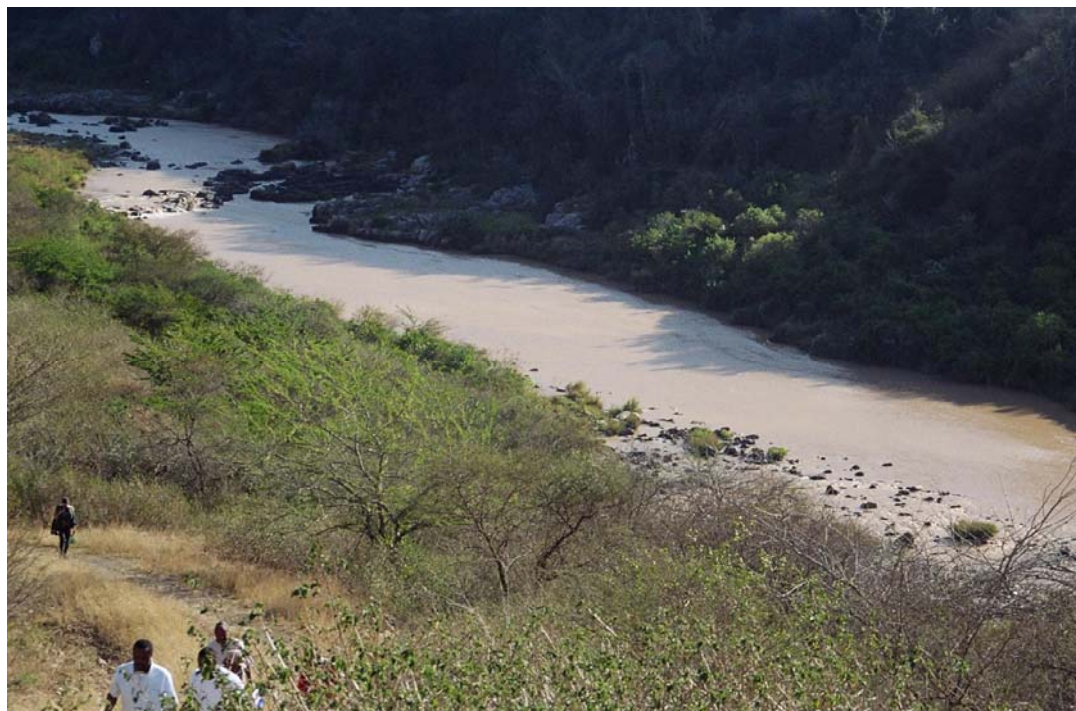
Plate 2.1 Mthatha River at Mpindweni showing the gorges and valleys of the lower catchment

The Mthatha River catchment is hilly with deep valleys and incised gorges (Plate 2.1). The dominant geological formations in the region are the Dwyka Foundation and the Beaufort Group. The Dwyka Foundation is fine-grained and compact, and thus forms a poor aquifer, with boreholes yielding less than 0.7 L/s. The Beaufort Group is mostly sandstone, and although the water quality is generally adequate for human consumption, the average yield of boreholes in this rock type is 0.5 L/s (DWAF, 2004a).

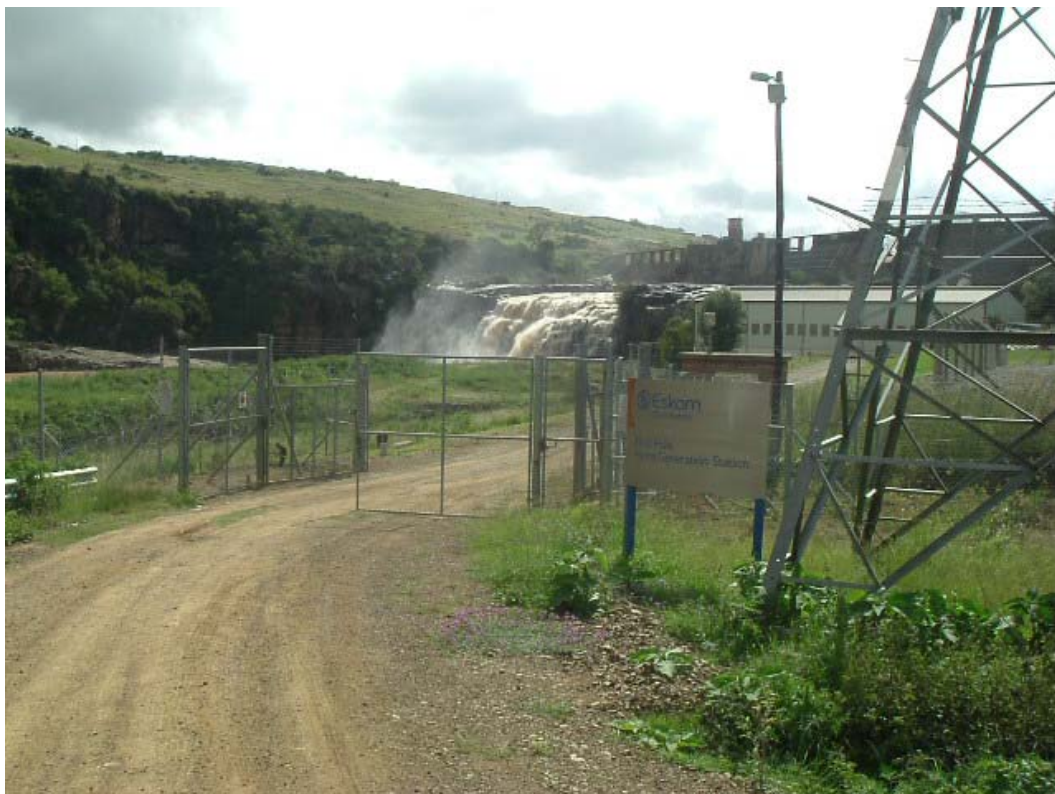
Plate 2.2 Hydropower plant at First Falls Dam on the Mthatha River

Another major user of water on the Mthatha River is ESKOM. ESKOM has two hydro-electricity generation stations at First and Second Falls. Plate 2.2 is a photograph of First Falls Dam taken in March 2005. An average of 170 million m³ water per annum is utilised, but since the water is returned to the river, this use is non-consumptive (DWAF, 2004a).

Hydropower generation generally takes place during the week with a shut down of the turbines over weekends (should Mthatha Dam not be spilling), unless there is a power shortage in the area (DWAF, 2001). Power generation will then be continued without warning or consultation. It was not possible to ascertain the pattern of releases during this study as records were not available and conflicting information was reported. It did however appear as if releases were being made for most of the survey periods, including the weeks preceding field trips (Kama, DWAF Mthatha, pers. comm.).

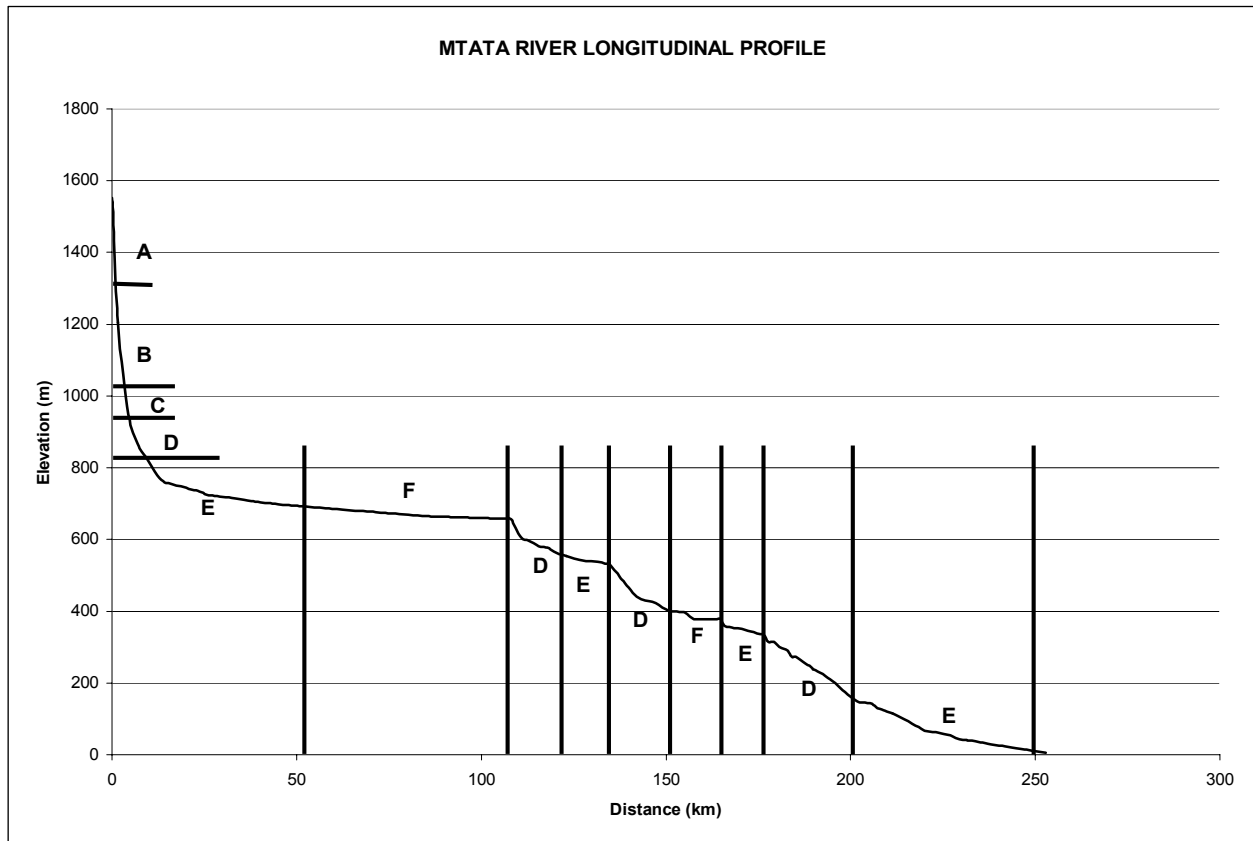
The longitudinal profile of the Mthatha River from source to mouth is presented in Figure 6.1. Zone breaks are indicated on the profile by heavy black lines. It should be pointed out that the zone class labels 'A', 'B', 'C' etc. refer to zone classes 'A' to 'F' presented in Table 6.1 (Rowntree et al., 2000) and *not* to impact classes 'A' to 'F' that are presented in Table 6.2.

Figure 6.1 Longitudinal profile of the Mthatha River indicating major geomorphological breaks

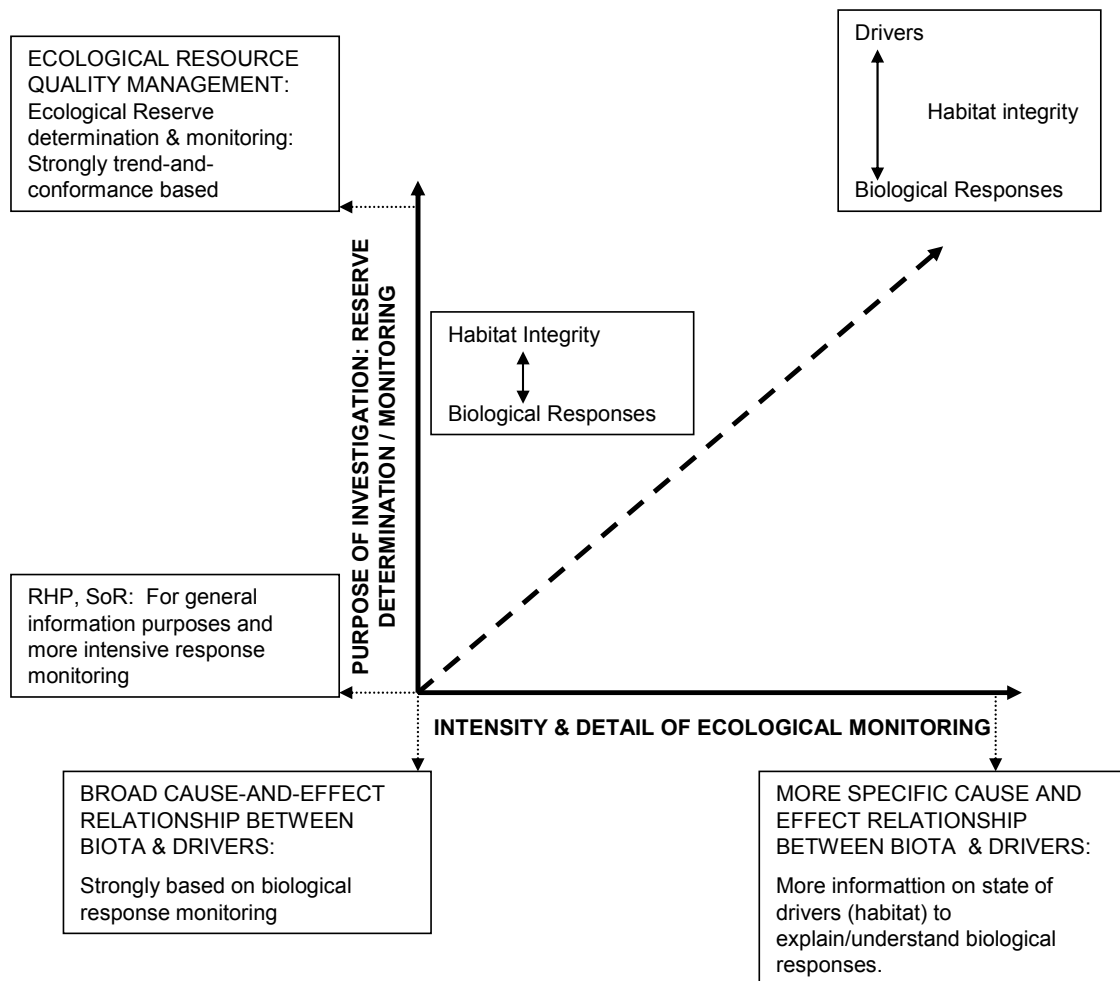
The general relationship between the levels of detail, scale and purpose for the Ecological Reserve and the RHP is indicated in Figure 8.1. Within the RHP the scale and delineation of the resource for EcoStatus assessments vary widely. Ecoregions form the basis of the assessment and, within these, catchments with similar kinds of impacts are usually combined, while DWAF management units are also taken into consideration. The combination of these are termed Assessment Units (Kleynhans et al., 2005). This approach was adopted for the Mthatha River biomonitoring programme, with Assessment Units defined for the catchment. These AU, and representative sampling sites in each AU, are defined in Chapter 2 of this report. All data were therefore collected and analysed per AU (Chapters 3-7), and habitat integrity determined per AU (this chapter). The EcoStatus was also determined per AU (this chapter).

Figure 8.1 Levels of detail for EcoStatus determination for Reserve and RHP purposes

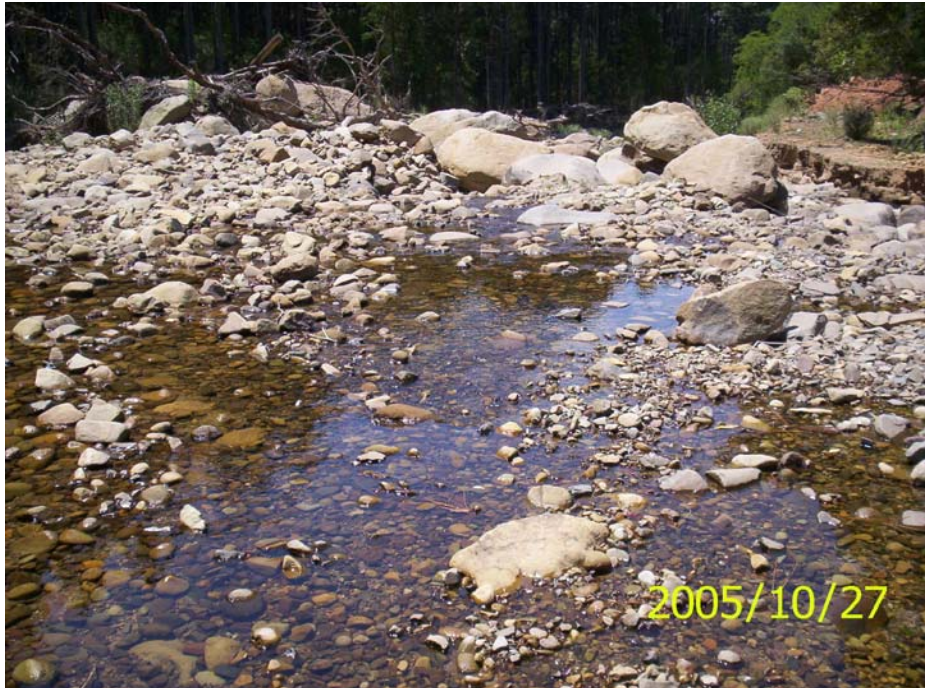
SITE 1, SOURCE OF THE MTHATHA RIVER: Least impacted site, although still located in commercial forestry plantations. Site was below the confluence of two mountain streams, with large boulders and loose gravel dominating the site. Site was on a gradient with large pools further downstream. Stream width approximately 2m.

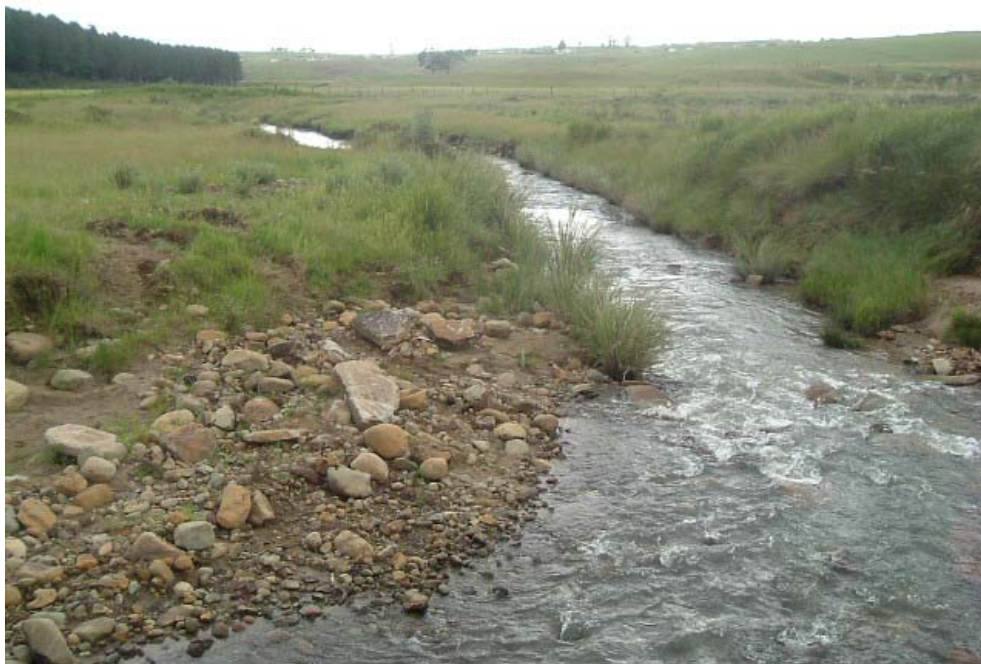
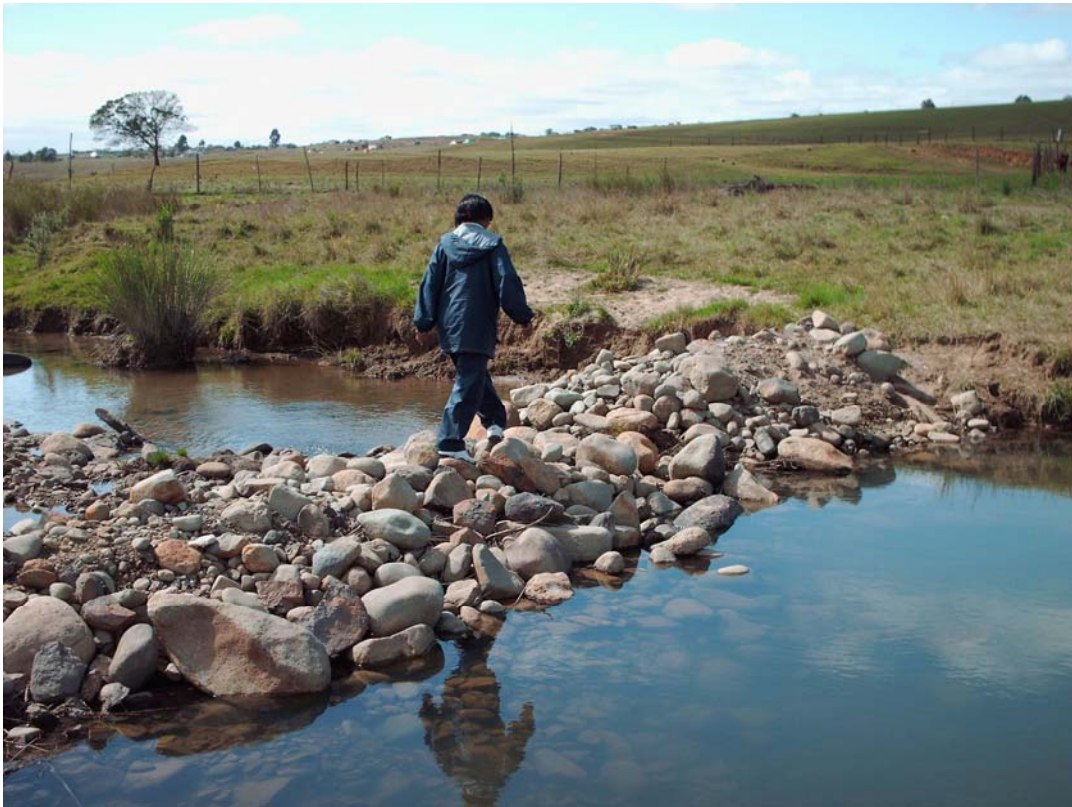
SITE 2, MTHATHA RIVER UPSTREAM OF LANGENI SAWMILLS: Long riffle stretch immediately downstream of the road bridge, with pools dominating just upstream of the bridge. Site very disturbed further down with a small access road bulldozed to the river on the left bank to collect water for dust suppression during road-building. A berm had also been constructed across the stream to contain water for collection.

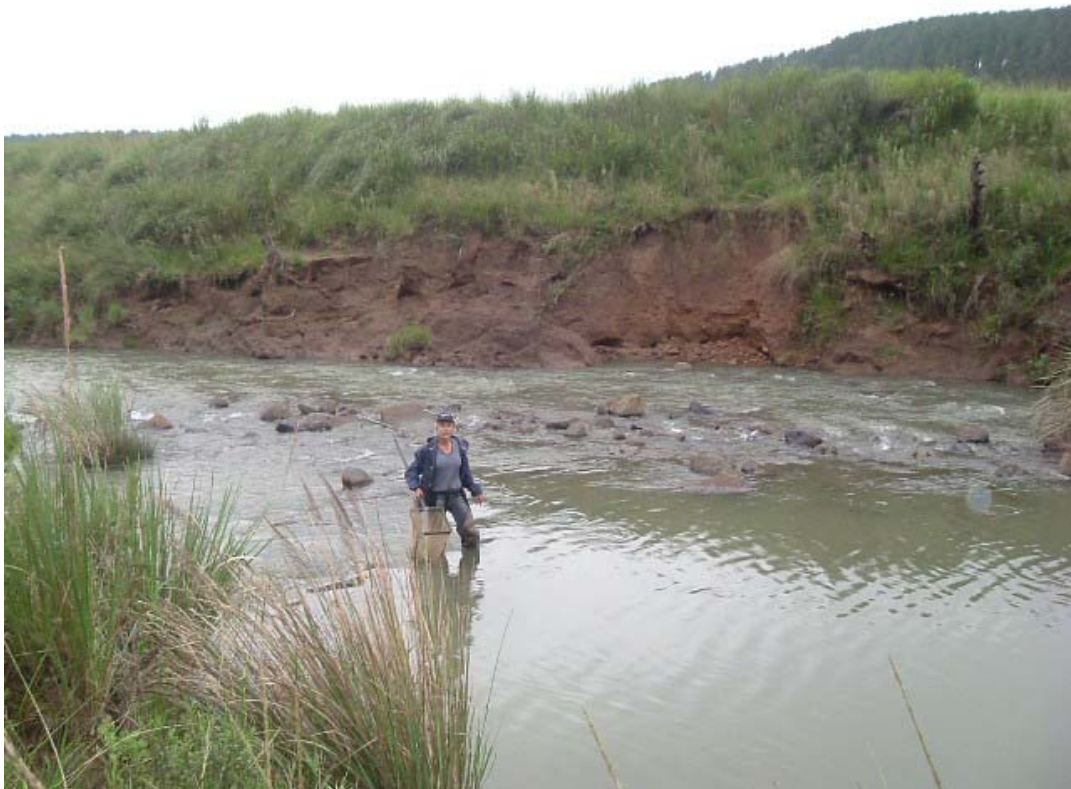
SITE 3, MTHATHA RIVER DOWNSTREAM OF LANGENI SAWMILLS: Site in meandering section of river; deep pools, runs and some riffle area present. Road and plantations on left bank. Disturbed riparian vegetation.

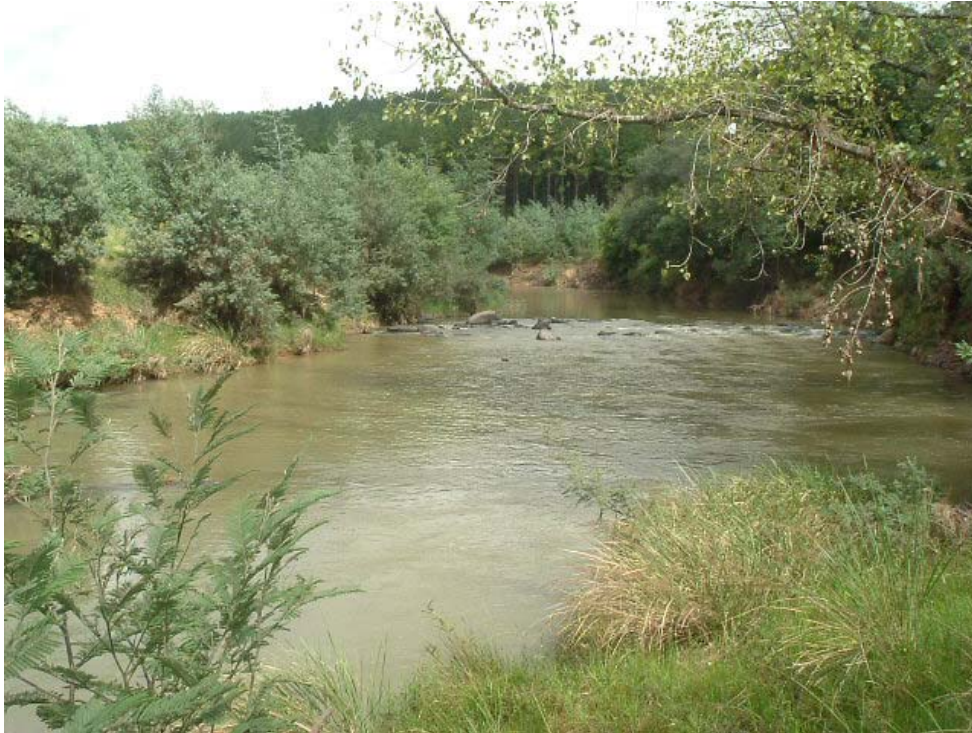
SITE 4, MTHATHA RIVER AT KAMBI FOREST STATION: The river channel is wide with flood damage evident upstream of the bridge. The river is shallow and sediment deposition is extensive. Pools evident, with little riffle area. The site is above Mthatha Dam.

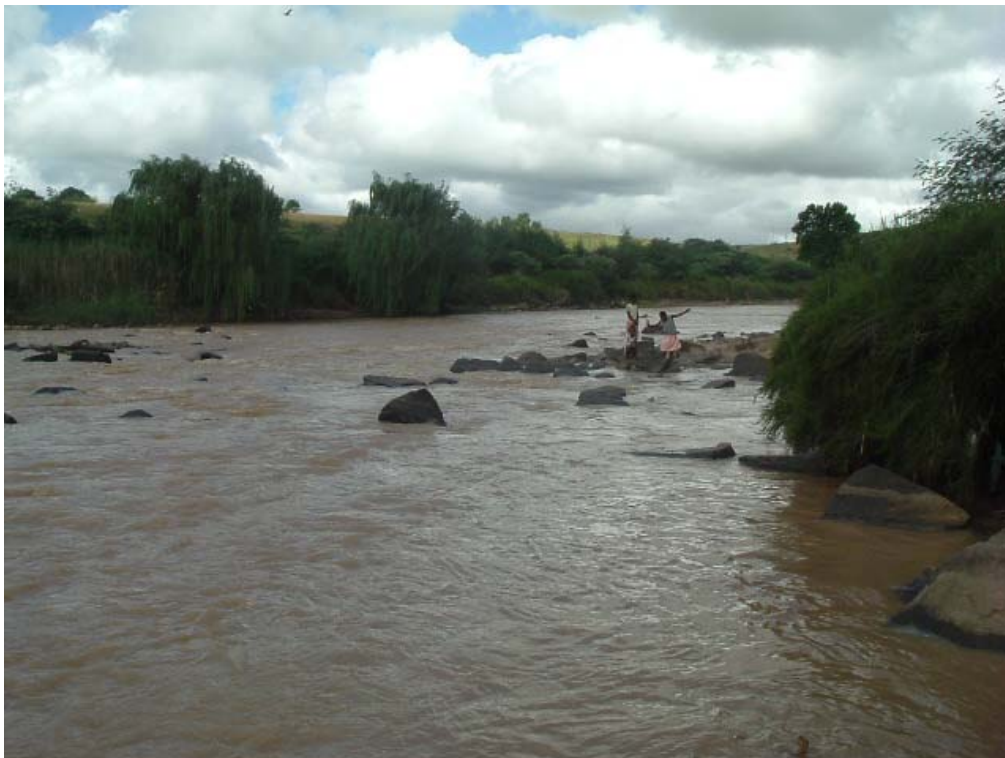
SITE 5, MTHATHA RIVER AT MTHATHA TOWN: The site is below Mthatha Dam, and is wide and fast-flowing. Quality conditions are very poor, with unserviced informal settlements located in the riparian zone. Little vegetation remains in the riparian zone.

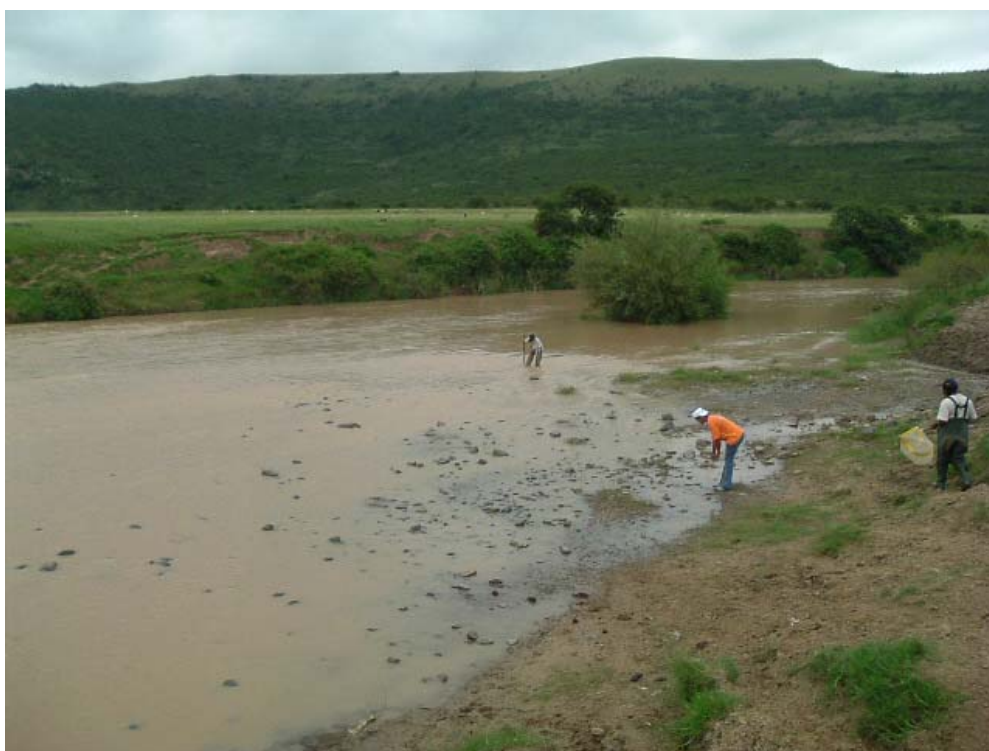
SITE 6, MTHATHA RIVER AT TAKATA: This site is below First Falls Dam, with the river channel being wide and shallow. Extensive pools and riffles are evident, although this stretch serves as a cattle crossing point. Disturbed riparian zone.

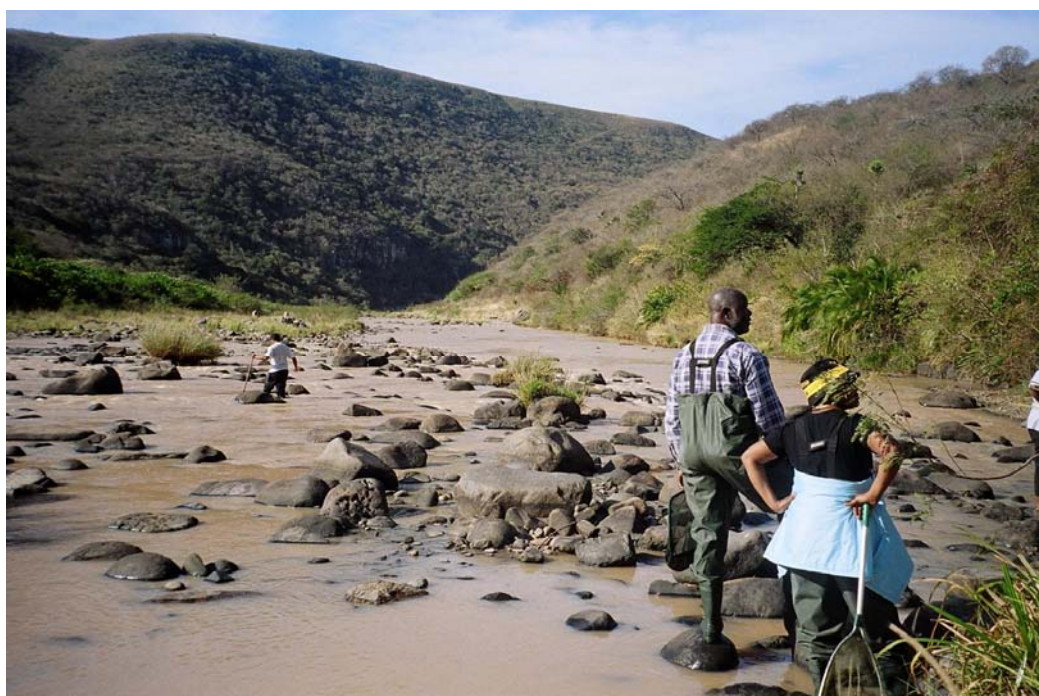
SITE 7, MTHATHA RIVER AT MPINDWENI: The terrain in this lower part of the catchment is very mountainous, with boulders dominating the instream habitat. The river is wide and fast-flowing, with the riparian zone being invaded by alien vegetation. The area is relatively unimpacted by settlements.

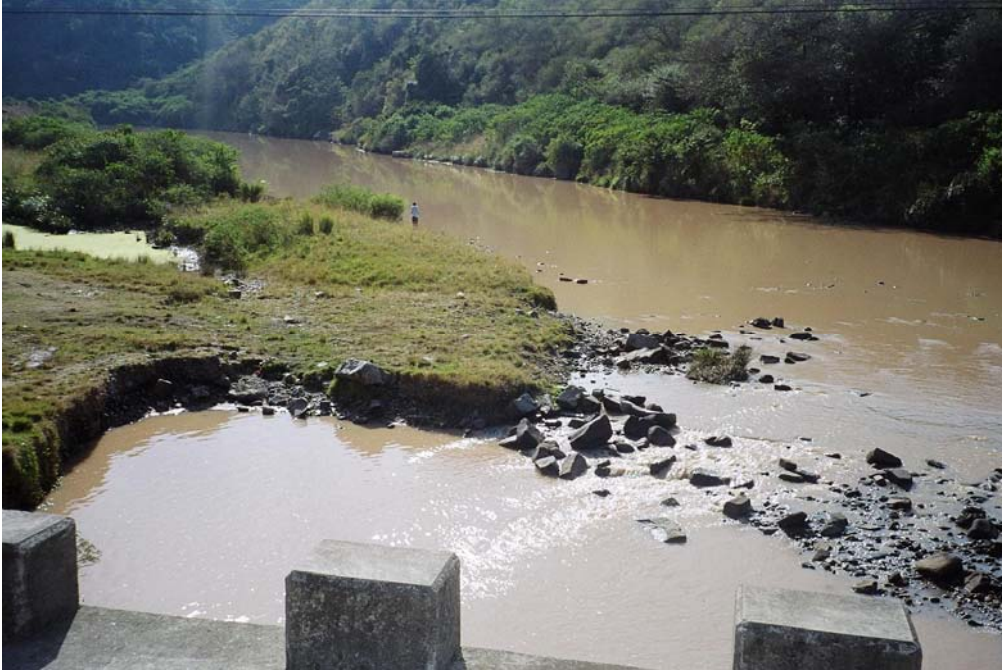
SITE 8, MTHATHA RIVER AT MDUMBI: This is the last site above the influence of the estuary. Water hyacinth was seen floating down the river at this point - the flow is slower than at Site 7. Pools and backwaters are seen at the site, with a riffle stretch below the bridge. The riparian zone is invaded by alien vegetation.

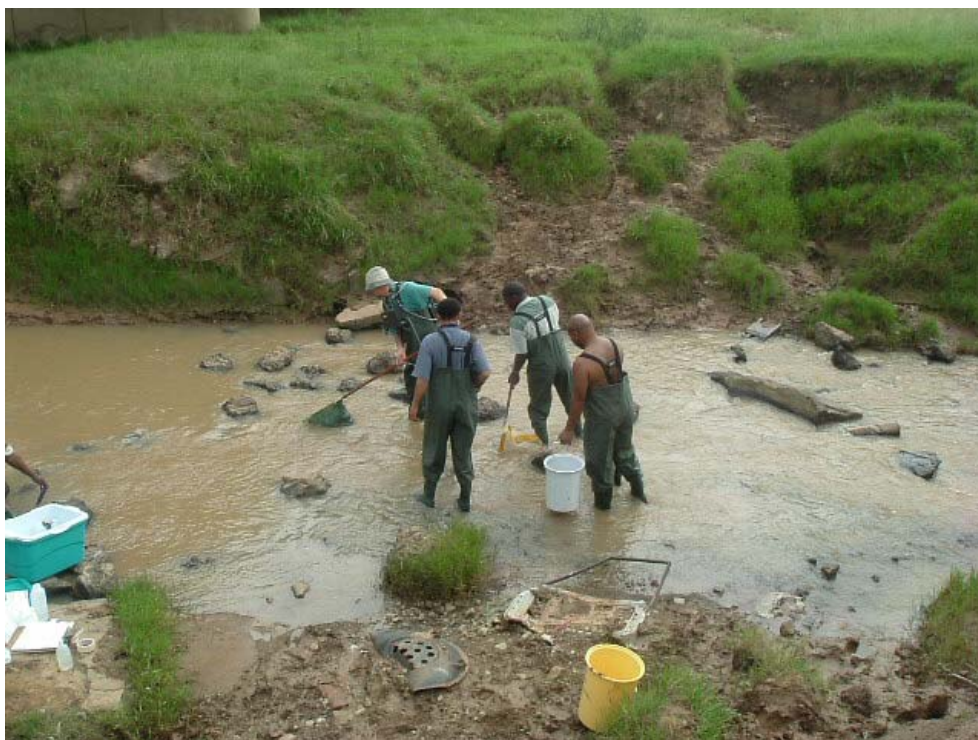
SITE 9, CICIRA RIVER: Tributary of the Mthatha River at Mthatha town and flowing into Mthatha Dam. Site is litter-infested, with a small channel (a few meters across) and little instream habitat. Pools are found under the bridge and downstream of the bridge. Rocks were extensively covered by algae indicating nutrient enrichment at the site.

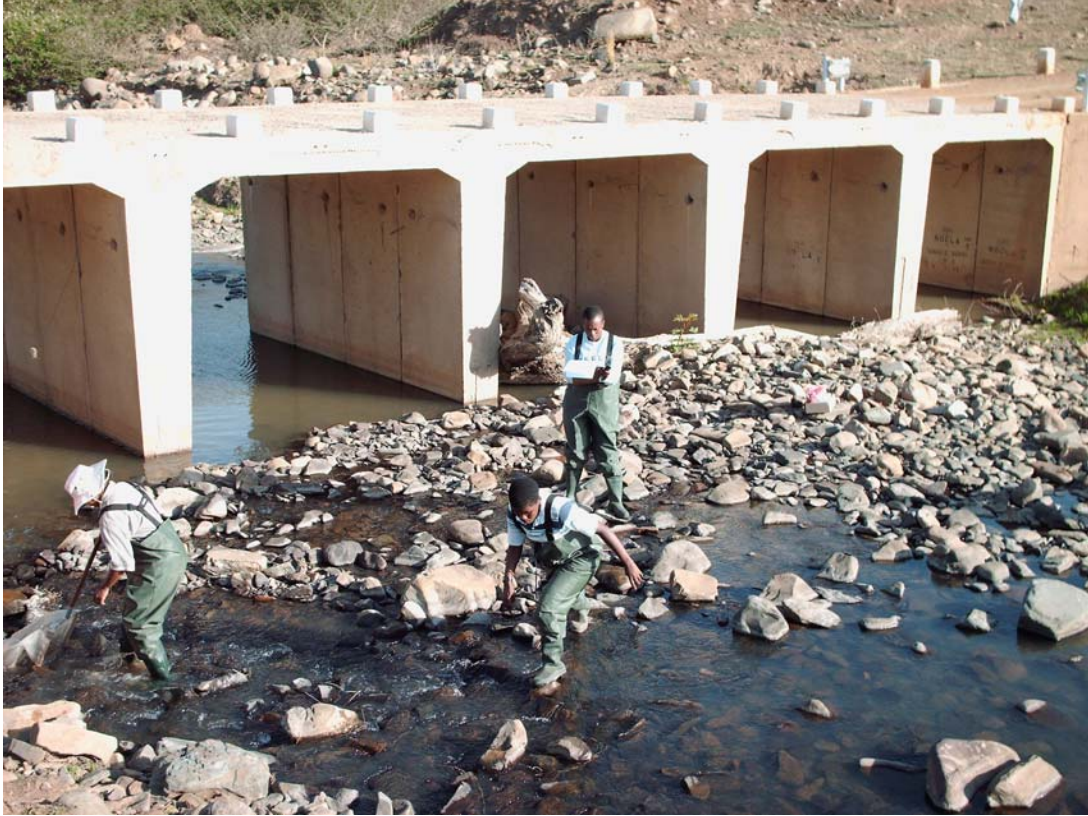
SITE 10, NGQUNGQU RIVER: Tributary in the lower section of the Mthatha River, which joins the main stem above sites 7 and 8. Extensive riffle stretch upstream of the bridge, with pools upstream and downstream of the road bridge. Little riparian vegetation upstream of the bridge due to the geology of the area. Few impacts in the area.
