**STATE-OF-RIVERS REPORT:
MONITORING AND MANAGING THE ECOLOGICAL STATE
OF RIVERS IN THE CROCODILE (WEST) MARICO
WATER MANAGEMENT AREA**

**RIVER HEALTH PROGRAMME
MARCH 2005**

STATE-OF-RIVERS REPORT NUMBER 9

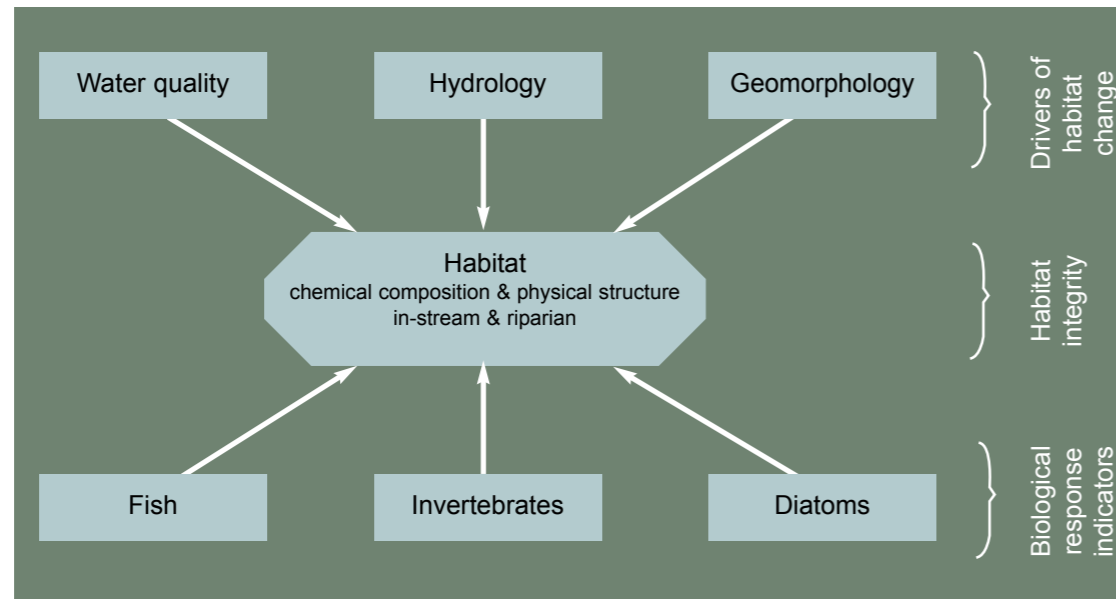
For this report, data was collected primarily on habitat integrity and the biological response indicators shown in the above figure. To achieve this, available water quality and flow data as well as an assessment of the geomorphological state of rivers were used in a qualitative way by experts in order to determine the habitat template to which aquatic biota would respond. The integrated response of the habitat to modifications and the response of the biota to this, determines the health of the surveyed rivers. The outcome of this overall assessment will be referred to as the EcoStatus and comprises six indicators, namely:

- Instream Habitat Integrity
- Riparian Zone Habitat Integrity
- Riparian Vegetation Integrity
- Fish Assemblage Integrity
- Macro-invertebrate Integrity
- Water Quality (as indicated by diatoms)

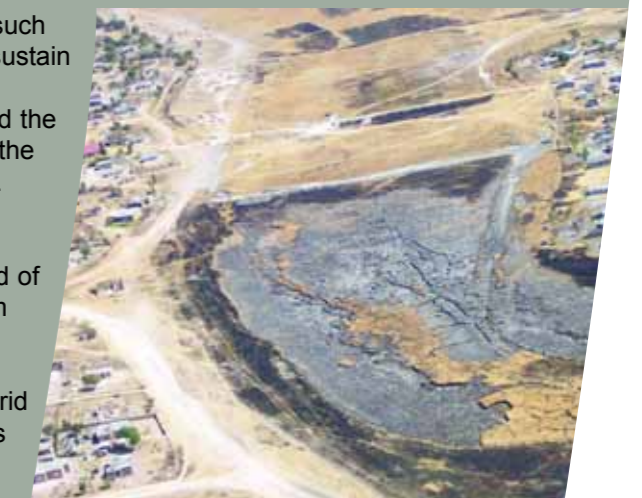
Burning peatland at Bodibe, near Mafikeng due to over utilisation of groundwater by local municipalities and farmers.

MANAGEMENT AND CONSERVATION CHALLENGES FOR THE BURNING BODIBE PEATLAND IN THE NORTH WEST PROVINCE

It is expected that with global climatic change peatlands in semi-arid regions will come under more pressure. These marginal peatlands such as Bodibe would eventually become a victim of struggle for water between man and the environment.

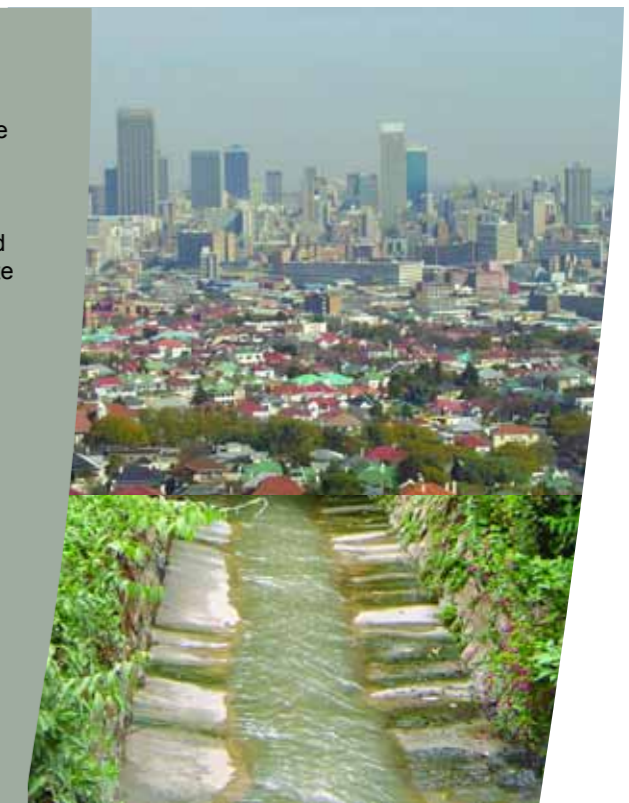
Johannesburg
Canalised stream running through Johannesburg
